Manhole Inspection Summary

Manhole # S15E__001MH

Insp Date: **10/5/07 9:52 AM**

Location Address: **231 CALVERTON AVE**

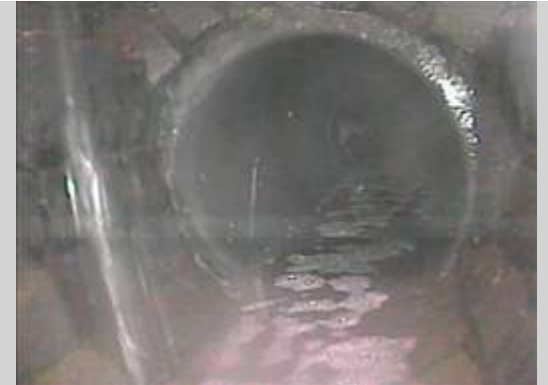
12 O'Clock Outflow

12 in. Circular Gravity Sewer
Pipe Out @ 12 O'Clock

Pipe Height: **12** (in.) Rod and Bar (Angled)
Pipe Material: **Clay** ☐ Pipe Lined
Invert Depth: **12.02** (ft.) Flow Characteristics: **Slow**
Deposits: ☒ None ☐ Mud ☐ Sludge ☐ Debris ☐ Grease
Silt Depth: (in.) Deposits Extent:
Infiltration: **None** Pipe Seal Cond: **Sound**

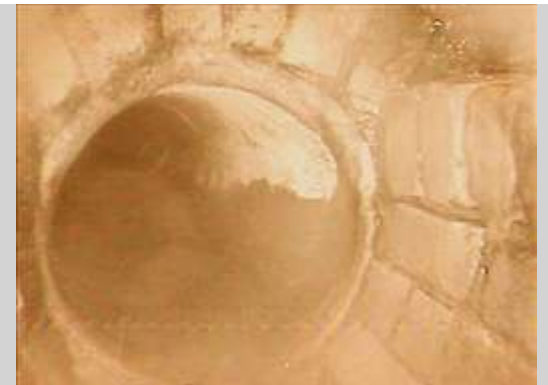
6 O'Clock Inflow

12 in. Circular Gravity Sewer
Pipe In @ 6 O'Clock

Pipe Height: (in.) Direct
Pipe Material: **Clay** ☐ Pipe Lined
Invert Depth: **10.99** (ft.) Flow Characteristics: **Slow**
Deposits: ☐ None ☐ Mud ☐ Sludge ☐ Debris ☒ Grease
Silt Depth: **0** (in.) Deposits Extent: **Light**
Infiltration: **None** Pipe Seal Cond: **Sound**

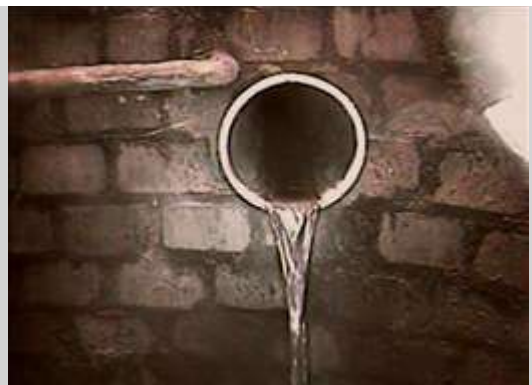
9 O'Clock Inflow

4 in. Circular Gravity Sewer
Pipe In @ 9 O'Clock

Pipe Material: **PVC** ☐ Pipe Lined

Invert Depth: **4.61** (ft.) Flow Characteristics: **Slow**

Deposits: ☒ None ☐ Mud ☐ Sludge ☐ Debris ☐ Grease

Infiltration: **None**

Pipe Seal Cond: **Sound**
